**GEOTECHNICAL INVESTIGATION**  
Transnet Beaconsfield Refuelling Depot,  
Kimberley Final Report

**REF NO.:** NH30-21

**DATE:** 15/12/2021

<b>Project Title</b>	<b>Geotechnical Investigation for The Construction Transnet Beaconsfield Refuelling Depot.</b>
<b>Report Title</b>	Geotechnical Investigation: Transnet Beaconsfield Refuelling Depot Final Report.
<b>Reference</b>	NH30-21 – Geotechnical Investigation: Transnet Beaconsfield Refuelling Depot Final Report.
<b>Date</b>	15/12/2021

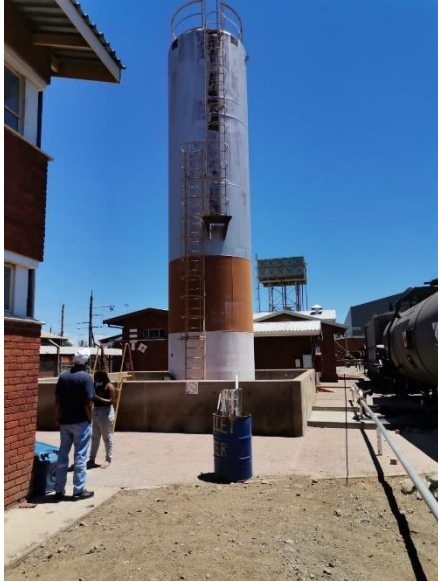
1. Existing refuelling depot structure

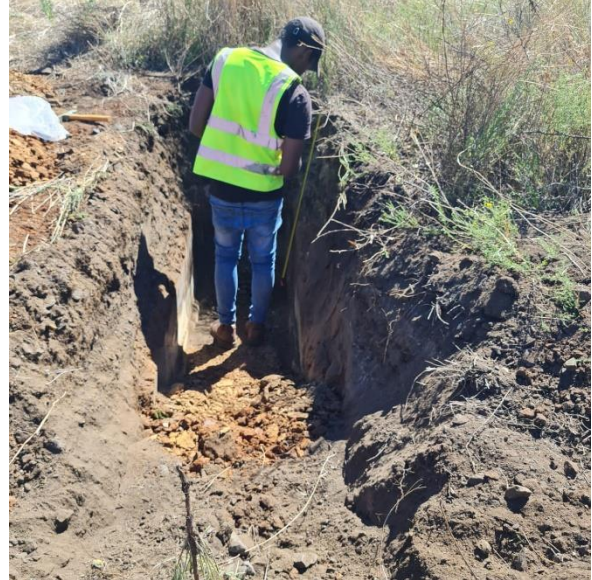
2. Typical soil profile in TP01

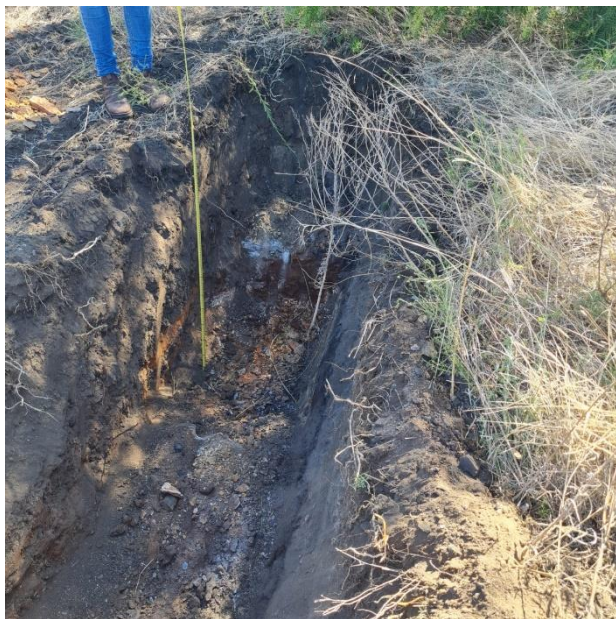
3. Typical soil profile at TP02.

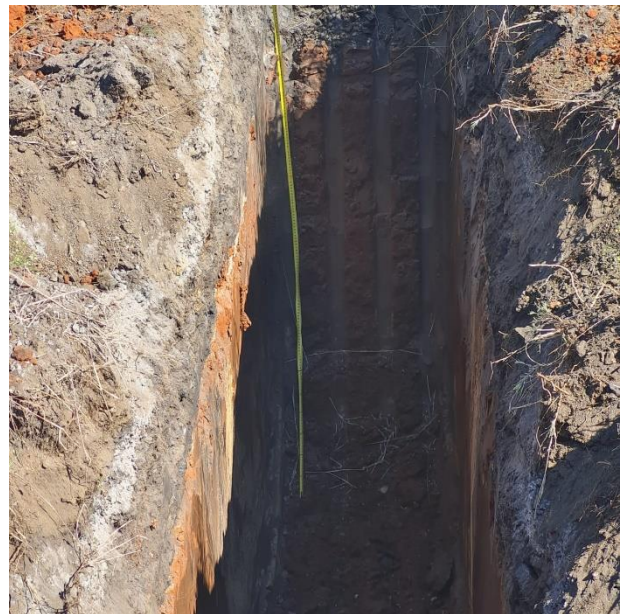
4. Typical soil at TP03.

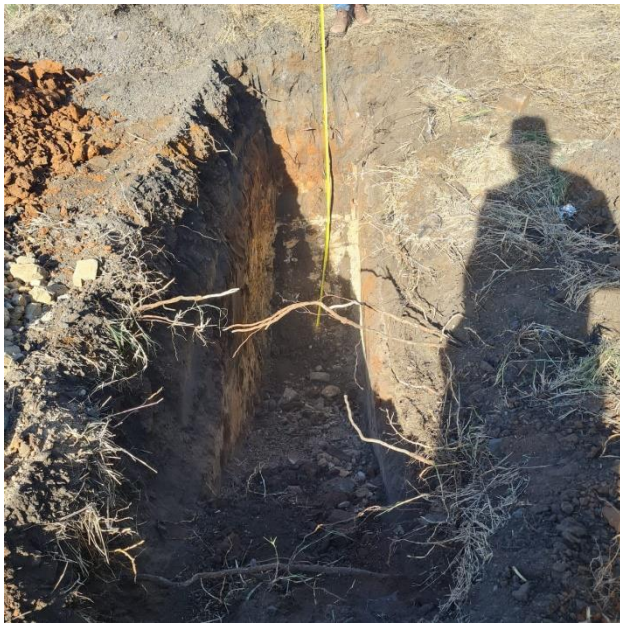
5. Typical soil profile in TP04

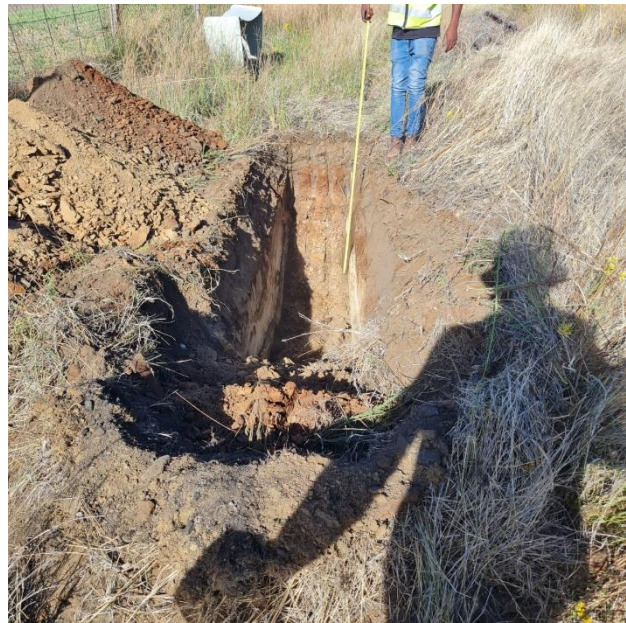
6. Typical soil from TP05

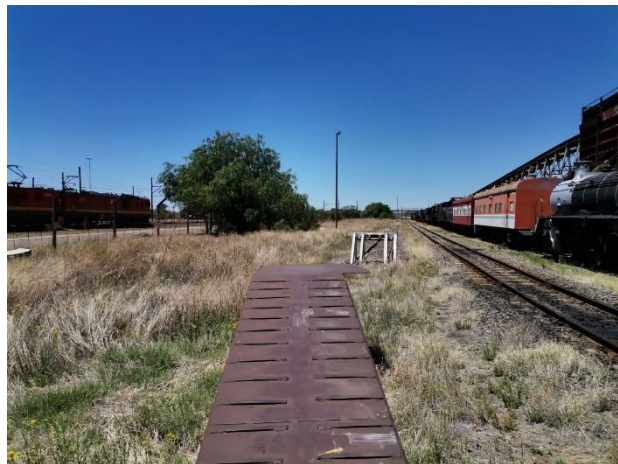
8. Existing railway structure on site

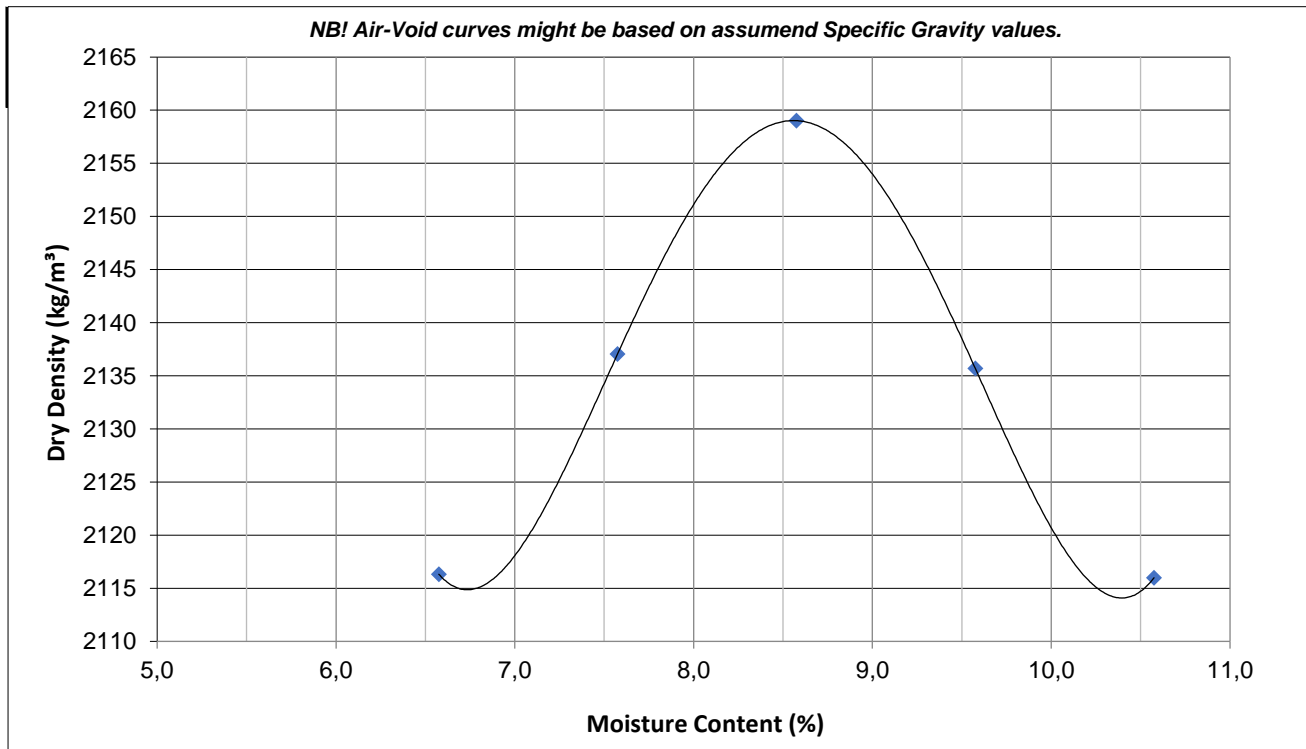
### Maximum Dry Density & Optimum Moisture Content - SANS 3001 GR30

Dry Density	kg/m <sup>3</sup>	2116	2137	2159	2136	2116	
Moisture Content	%	6,6	7,6	8,6	9,6	10,6

Max. Dry Density	kg/m <sup>3</sup>	2159
Optimum Moisture	%	8,6
